Manhole Inspection Summary

Manhole # S33AA_021MH

Insp Date: **1/24/08 12:27 PM**

Location Address: **MORTON ST**

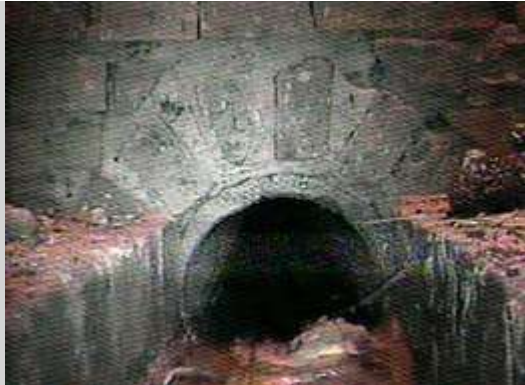
12 O'Clock Outflow

8 in. Circular Gravity Sewer
Pipe Out @ 12 O'Clock

Pipe Height: (in.) Direct
Pipe Material: **Clay** ☐ Pipe Lined
Invert Depth: **10.75** (ft.) Flow Characteristics: **Slow**
Deposits: ☒ None ☐ Mud ☐ Sludge ☐ Debris ☐ Grease
Silt Depth: (in.) Deposits Extent:
Infiltration: **None** Pipe Seal Cond: **Sound**

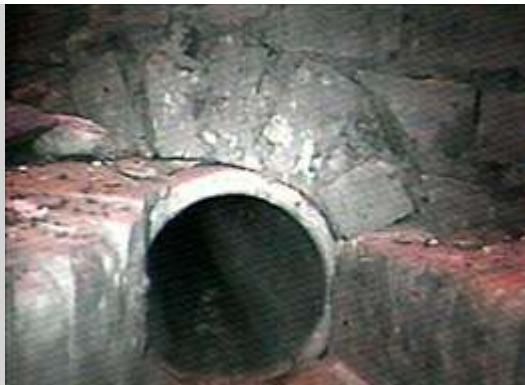
5 O'Clock Inflow

8 in. Circular Gravity Sewer
Pipe In @ 5 O'Clock

Pipe Height: (in.) Direct
Pipe Material: **Clay** ☐ Pipe Lined
Invert Depth: **10.65** (ft.) Flow Characteristics: **Slow**
Deposits: ☒ None ☐ Mud ☐ Sludge ☐ Debris ☐ Grease
Silt Depth: (in.) Deposits Extent:
Infiltration: **None** Pipe Seal Cond: **Sound**

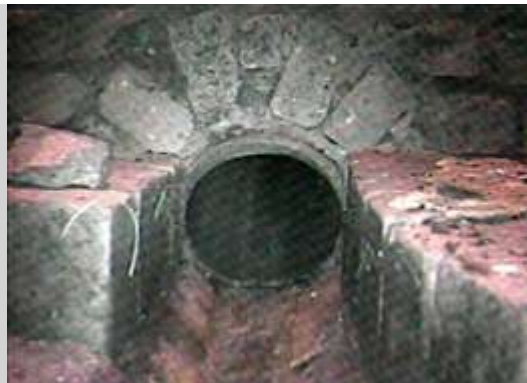
7 O'Clock Inflow

8 in. Circular Gravity Sewer
Pipe In @ 7 O'Clock

Invert Depth: **10.70** (ft.) Flow Characteristics: **Slow**

Infiltration: **None**

Pipe Seal Cond: **Sound**
